## CASE STUDY - CAR DETAILING

CS012

**Client:** Car Detailing Company

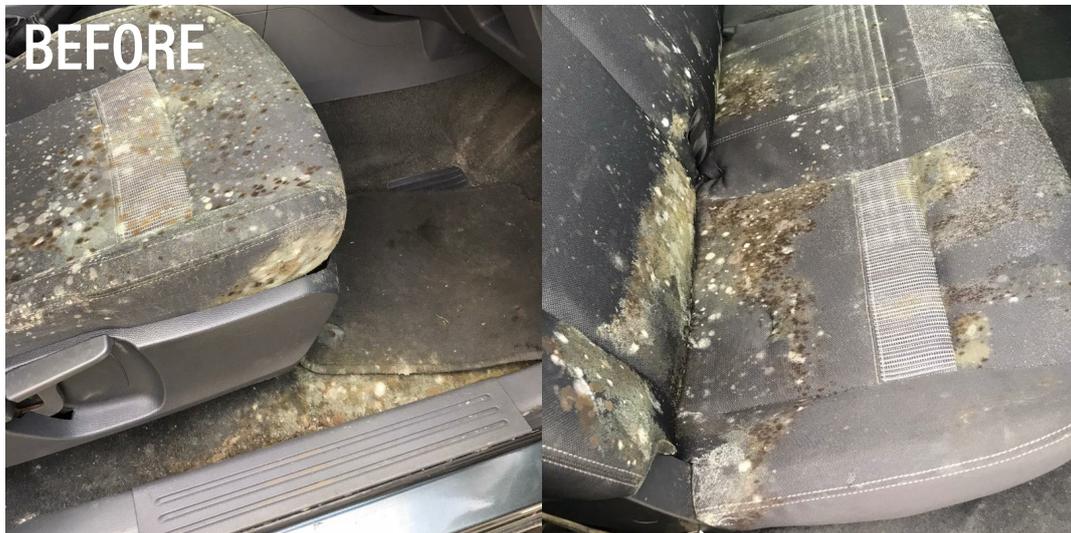
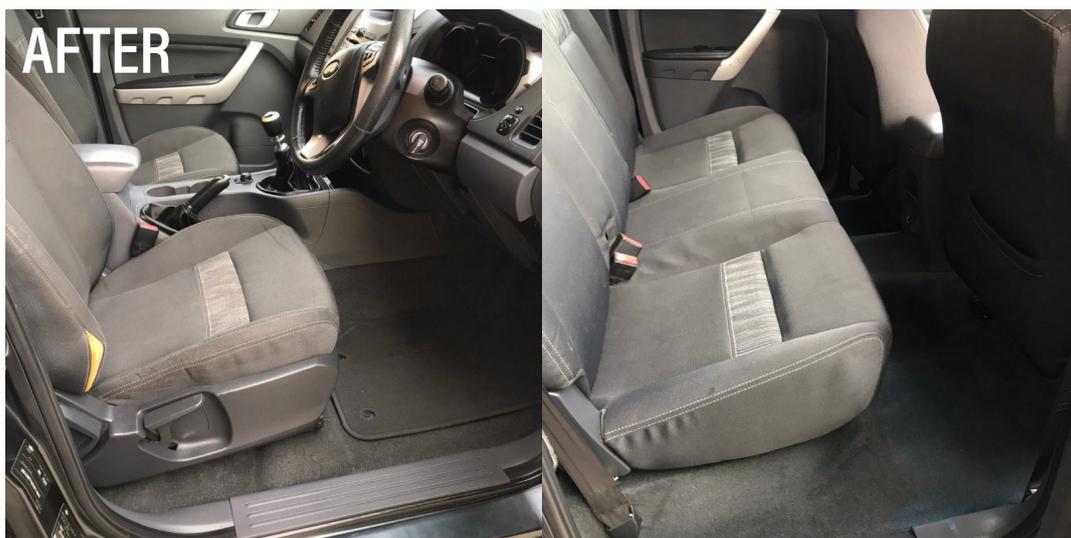
A car remained static for many months in a situation where moisture was entering into the car through the boot. The moisture worked its way into the cabin of the car. Mould took hold and quickly grew on most internal surfaces within the car.

All internal surfaces within the car were sprayed with 250ml of SAN-AIR Surface Mould Remover. The car was then left to dry over the weekend. When the client returned on Monday morning, he noticed that the internal surfaces were covered with a powdery, flaky substance, which appeared to be dried up mould. The surfaces were then vacuumed with a commercial vacuum cleaner. The AFTER photos were taken directly after vacuuming. SAN-AIR followed up three months later and the mould had not returned.
